INTEGRATED VEHICLE HEALTH MANAGEMENT

A Microwave Blade Tip Clearance Sensor for Propulsion Health Monitoring

Aviation Safety Program Technical Conference
November 17-19, 2009
Washington D.C.

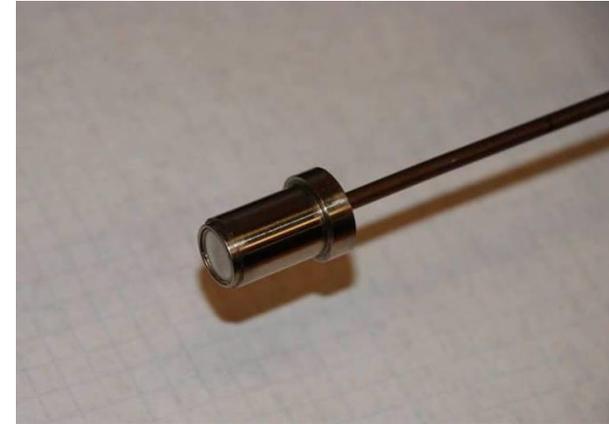
Microwave Tip Clearance Probe

- Clearance Probe
 - Contains Transmitting/Receiving Antenna
 - Installed in the engine casing
 - First generation probes (5.8 GHZ) are designed to be used on “large” rotating machinery
 - Measurement range ~25mm (~1”)
 - Second generation probes (24 GHZ) are for aero engine size hardware and clearances
 - Measurement range ~6mm (~1/4”)
- Sensor Electronics
 - Contains the microwave generator and detector
 - Data acquisition & display computer
 - Located off board of test article or engine
 - Connected to sensors via co-axial cable

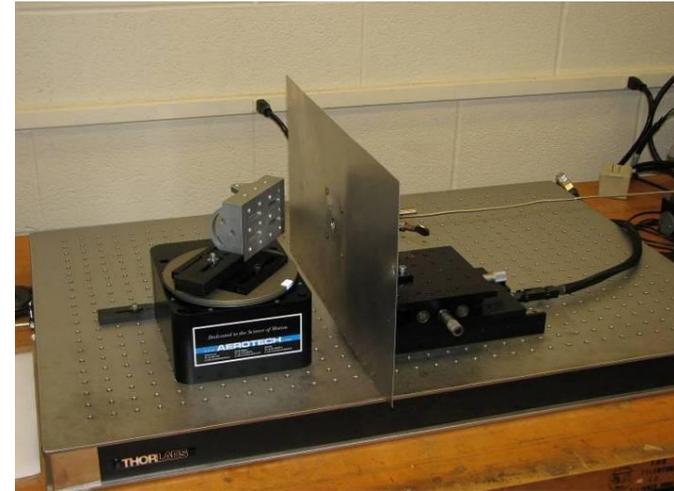
Probe Calibration Rig

- Calibrated the microwave sensors against two geometries
 - “Thin” compressor blade (~6 mm thick)
 - “Thick” simulated fan blade (~26mm thick)

- Outcome / Results:
 - Developed techniques and infrastructure required for calibration
 - Observed worst case error of ~+/- 0.15mm during this initial experiment
 - Reduced to ~+/- 0.05mm in subsequent calibration experiments for use on NASA Turbofan

- Experimental Setup:
 - Calibrated sensors using a “old” compressor stage from a T700 as the target
 - Installed the compressor stage on the microwave sensor calibration rig
 - Calibration rig previously shown in slides 10 & 15
 - Calibrated over a range from 0.10mm to 1.50mm for this sensor calibration experiment

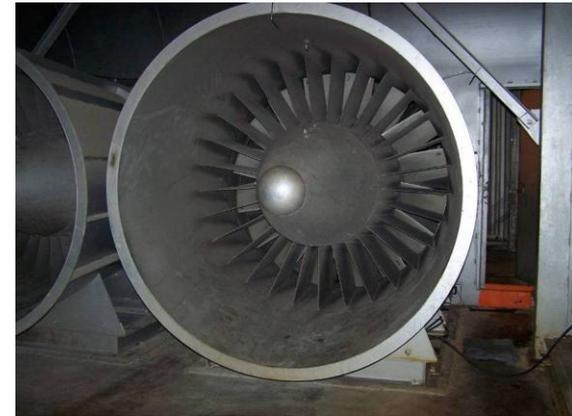
Axial Vane Fan at the Glenn Research Center's 10x10 Wind Tunnel

- Axial Van Fan
 - 1.8 M Diameter, operates at 1200 RPM
 - 16 Blades, ~26 mm thick, ~362 mm long, ~267 mm chord length
 - One 5.8GHZ probe installed

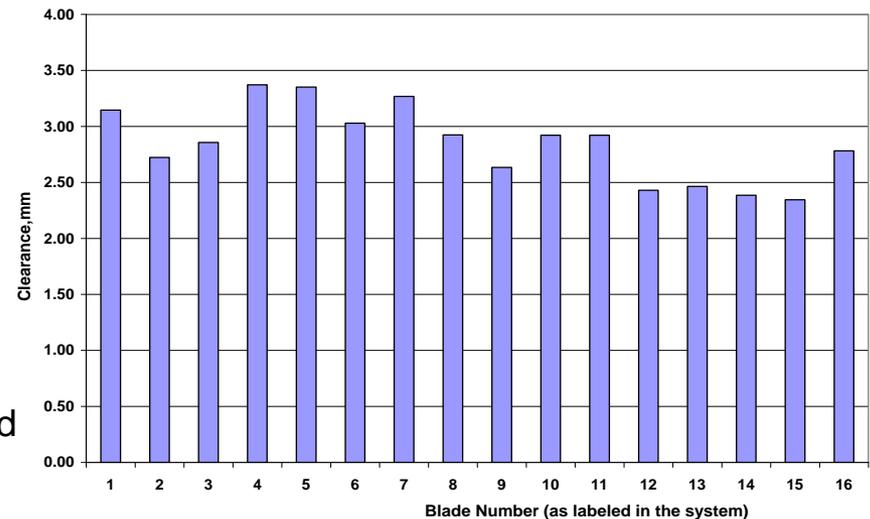
Axial Vane Fan – Blade Tip Clearances for 1/Rev

Individual Tip Clearance Measurements - One Revolution, Run #5
 Probe Polarity Aligned Parallel to Blade Tip, Synchronous Data Mode

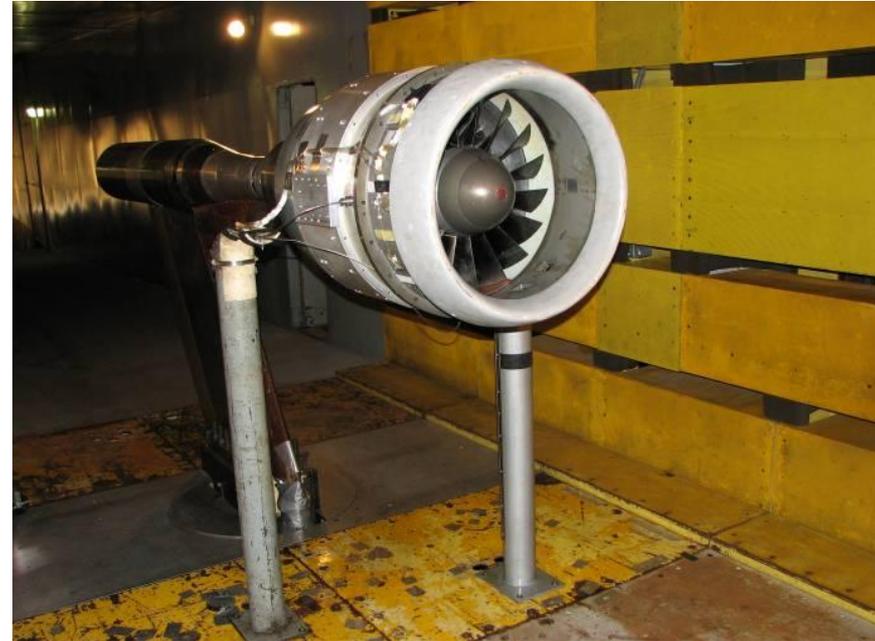
NASA Turbofan at the Glenn Research Center's 9x15 Wind Tunnel

- Objectives:
 - Demonstrate the microwave sensors ability to acquire blade tip clearance measurements on an aero engine size test article and blades
- NASA Turbofan
 - Subscale turbofan propulsion simulator
 - 2 probes (5.8GHZ) installed, 90° apart
 - 18 Composite Blades
 - Blade tips were coated with nickel to allow measurement by microwave probes
- Outcome / Results:
 - Acquired tip clearance data for several test runs of the turbofan
 - The change in tip clearances measured during fan operation was in-line with previous data acquired with capacitive probes on earlier test entries
 - Demonstrated the sensor's ability to make measurements on "aero" engine size hardware

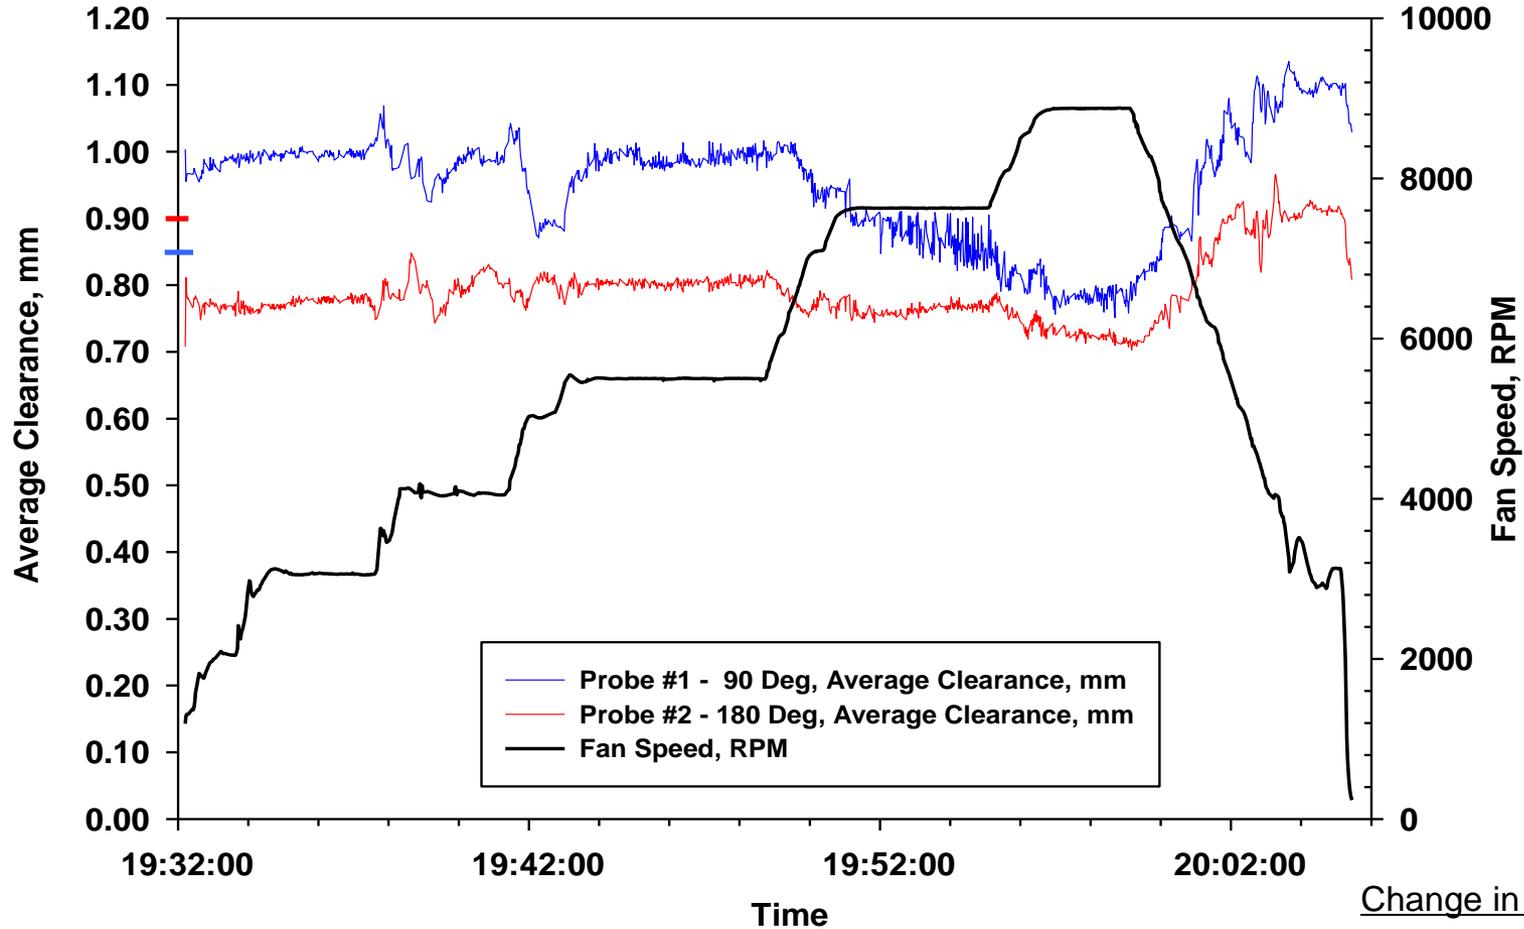
Average Blade Tip Clearances (mm) and Fan Speed versus Time,
Probes #1 & #2, Run #7 9-23-2008

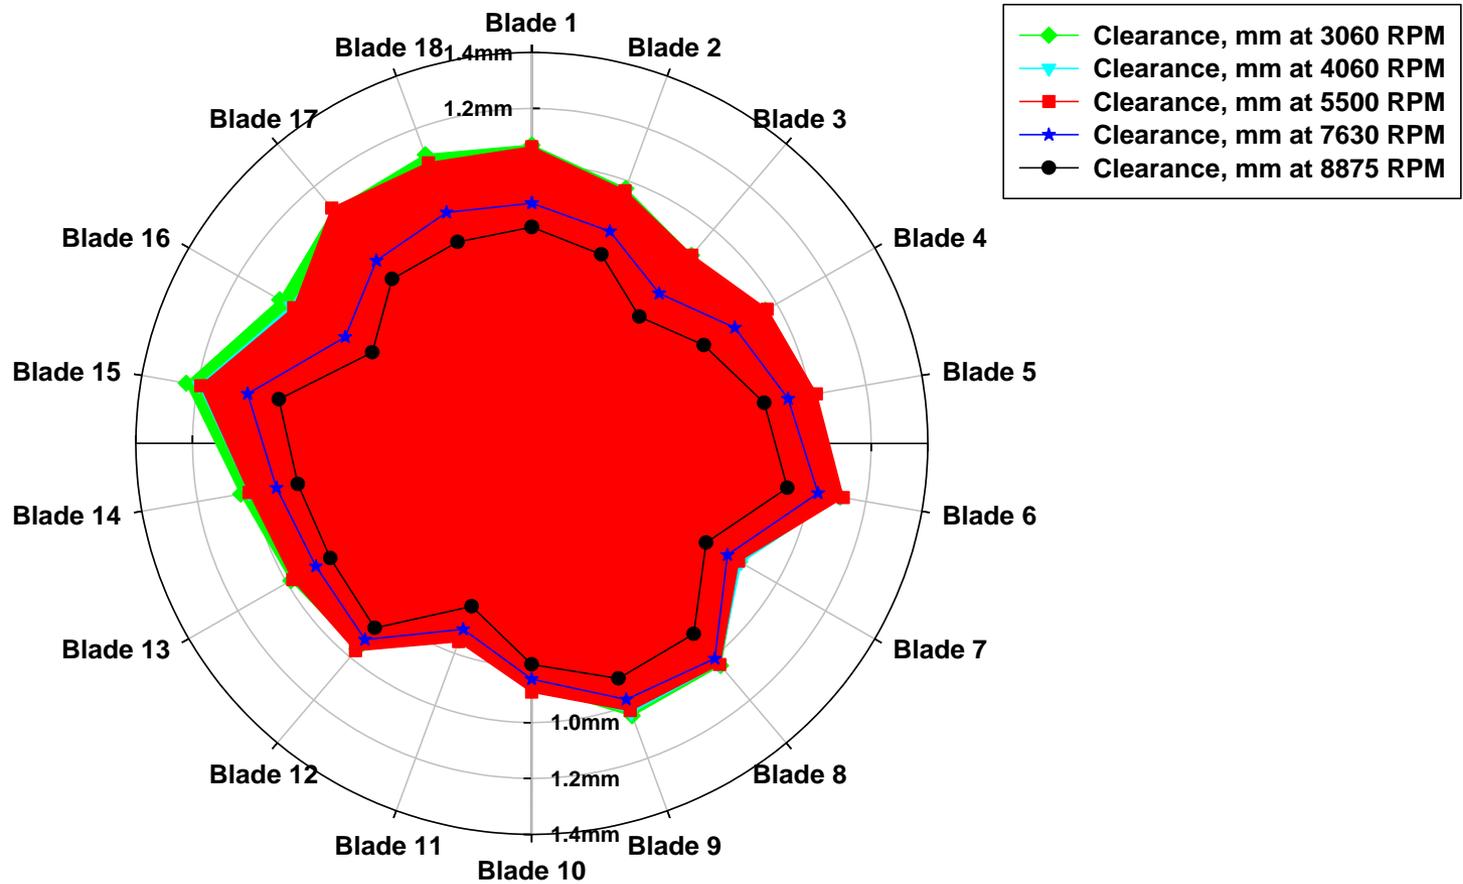
Polar Plot, Clearance vs Speed
Blade Tip Clearances in mm, Probe #1, 90 Degree Position
Run #7 9-25-2008

Average $\Delta = \sim 0.22$ mm

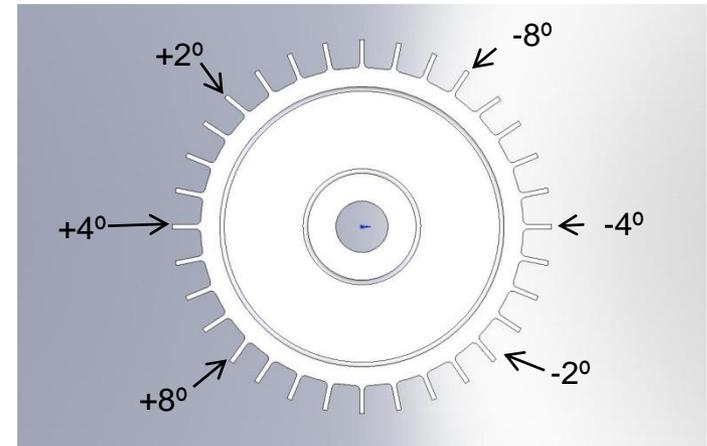
Bent Blade Disk Concept

- ~25cm (10") diameter disk with 32 blades installed on sensor calibration rig
- 6 symmetrically spaced blades were bent at pre-defined angles (proof of concept test)
 - +/- 8°, +/- 4°, +/- 2° deflections
- Calibrated at clearances down to 0.100mm
 - First Cal Run, 0.10mm to 0.60mm
 - Second Cal Run, 0.05mm to 0.70mm
